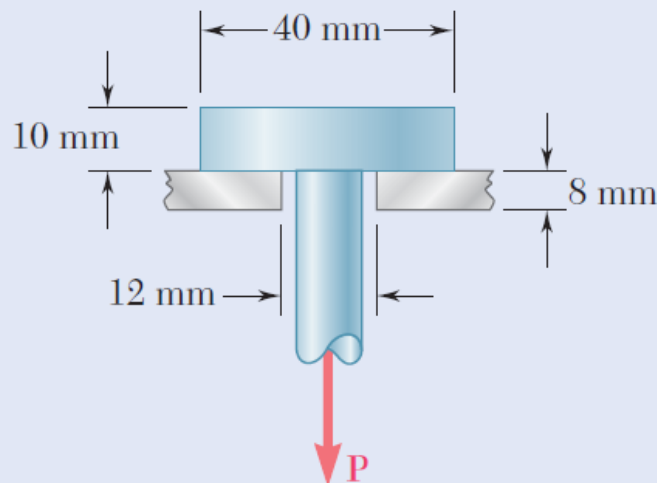
2. A load \mathbf{P} is applied to a steel rod supported as shown by an aluminum plate into which a 12-mm-diameter hole has been drilled. Knowing that the shearing stress must not exceed 180 MPa in the steel rod and 70 MPa in the aluminum plate, determine the largest load \mathbf{P} that can be applied to the rod.

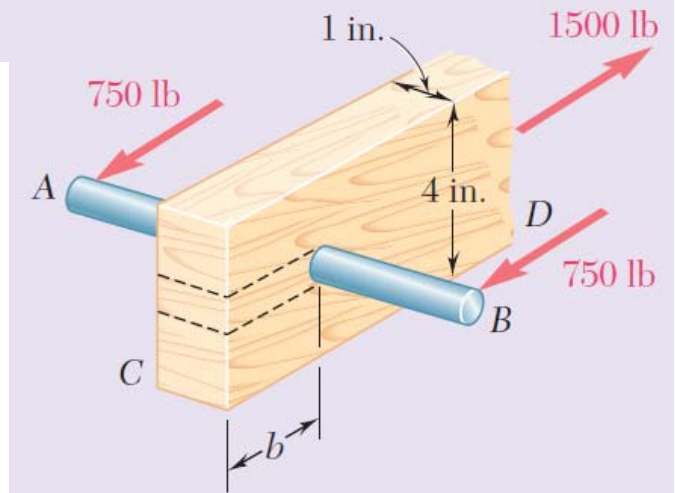
4. A $\frac{5}{8}$ -in.-diameter steel rod AB is fitted to a round hole near end C of the wooden member CD . For the loading shown, determine (a) the maximum average normal stress in the wood, (b) the distance b for which the average shearing stress is 100 psi on the surfaces indicated by the dashed lines, (c) the average bearing stress on the wood.

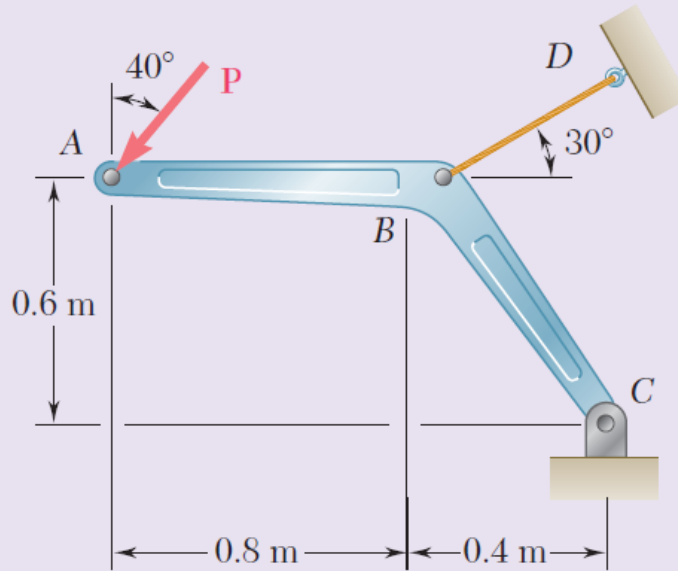
5. Member ABC , which is supported by a pin and bracket at C and a cable BD , was designed to support the 16-kN load \mathbf{P} as shown. Knowing that the ultimate load for cable BD is 100 kN, determine the factor of safety with respect to cable failure.
